Midway Atoll National Wildlife Refuge

Historic Preservation Plan 2010

December 2010

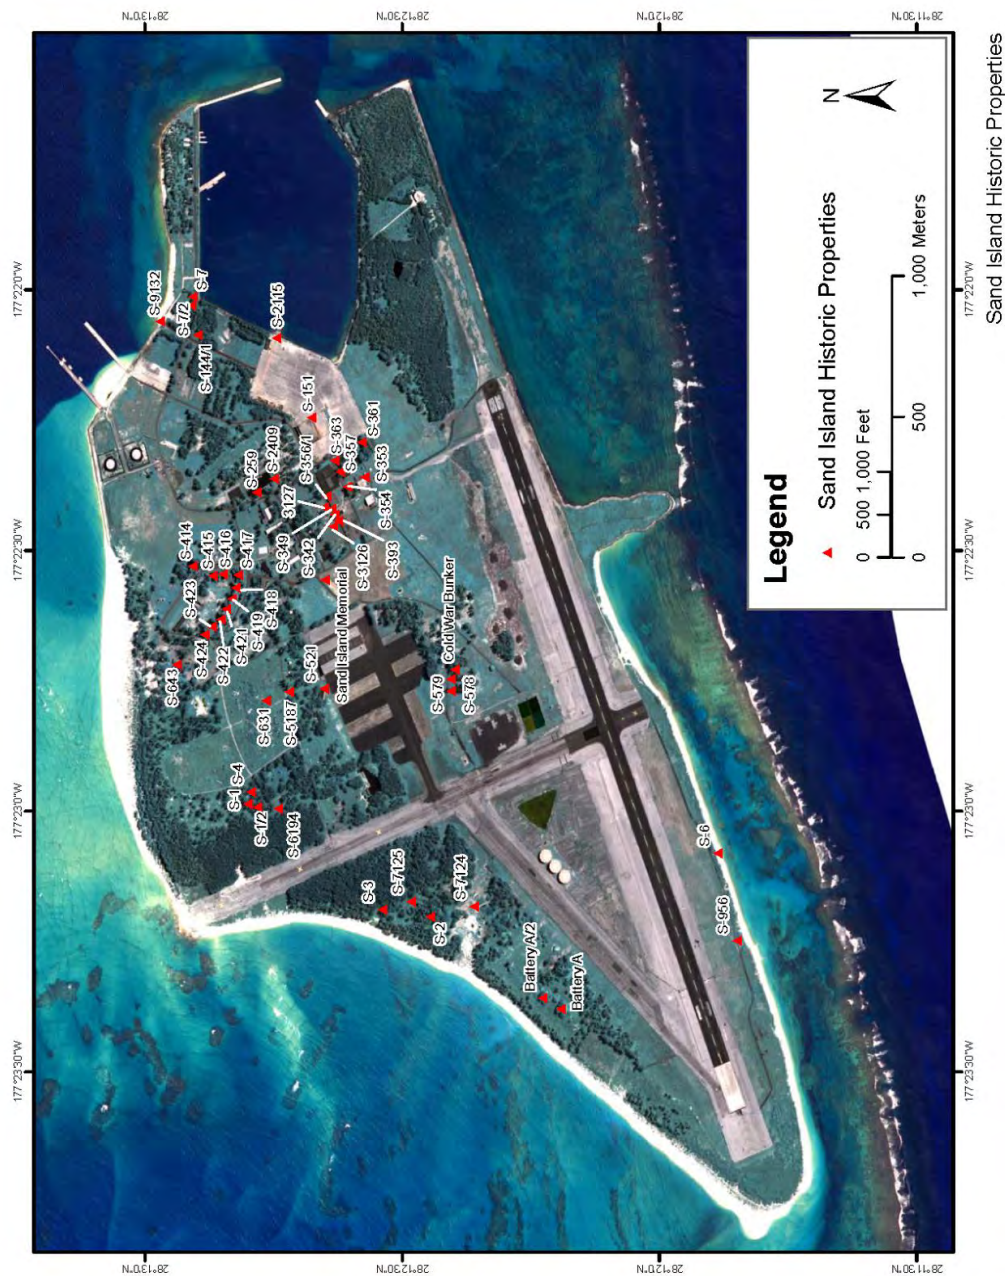
Figure 2. Sand Island Map with Historic Properties Identified (map prepared by NOAA).

Midway Atoll National Wildlife Refuge (NWR) is located within Region 1 of the U.S. Department of the Interior, Fish and Wildlife Service (FWS). Situated at the northern extent of the Hawaiian Islands, approximately 1,250 miles northwest of Honolulu, Midway comprises a roughly circular outer reef approximately 5 miles in diameter that encloses a central lagoon and two main islands, Sand and Eastern (Figure 1). Sand Island contains the highest number of historical resources as well as visitor facilities (Figure 2). Eastern Island contains no operational facilities except a boat dock (Figure 3).

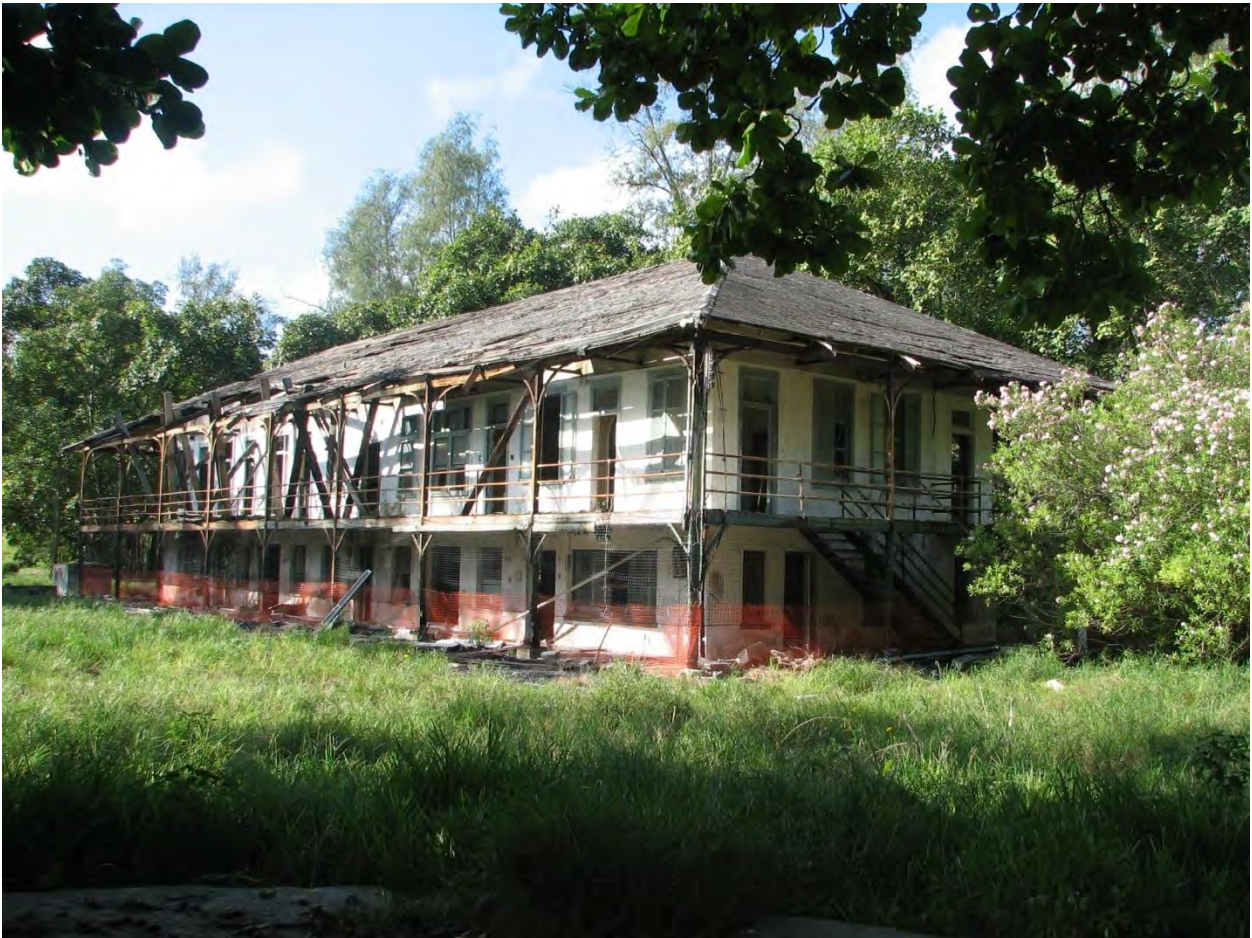
Cable Station Building 623, Sand Island (Speulda-Drews, 2007-10-03:295)

A major failure in the initial implementation of the 1999 HPP was the near complete loss of the Cable Station buildings. The Cable Station buildings 628, 619, and 623 were not adequately secured prior to the Navy's 1997 transfer, and the harsh climate and fragile condition of the buildings has set off a chain of events that hastened their deterioration. The buildings lost their structural integrity once holes in the roof allowed water to enter the buildings. Because of the deterioration and safety issues surrounding the three collapsing buildings, the decision was made to "Salvage and Dismantle" them. In 2008, the original windows, doors, and hardware were salvaged from the three buildings and stored in Cable Building 643. However, there still remain hazards such as peeling lead paint, crumbling structural steel, spalling concrete walls, and collapsing verandahs. Cable Building 643 has been "Mothballed," with windows and doors closed and support provided to the verandahs. Additionally, rust inhibiting paint has been used to treat the exposed steel columns and stair railings. But, the condition of Cable Building 643 is still tenuous.

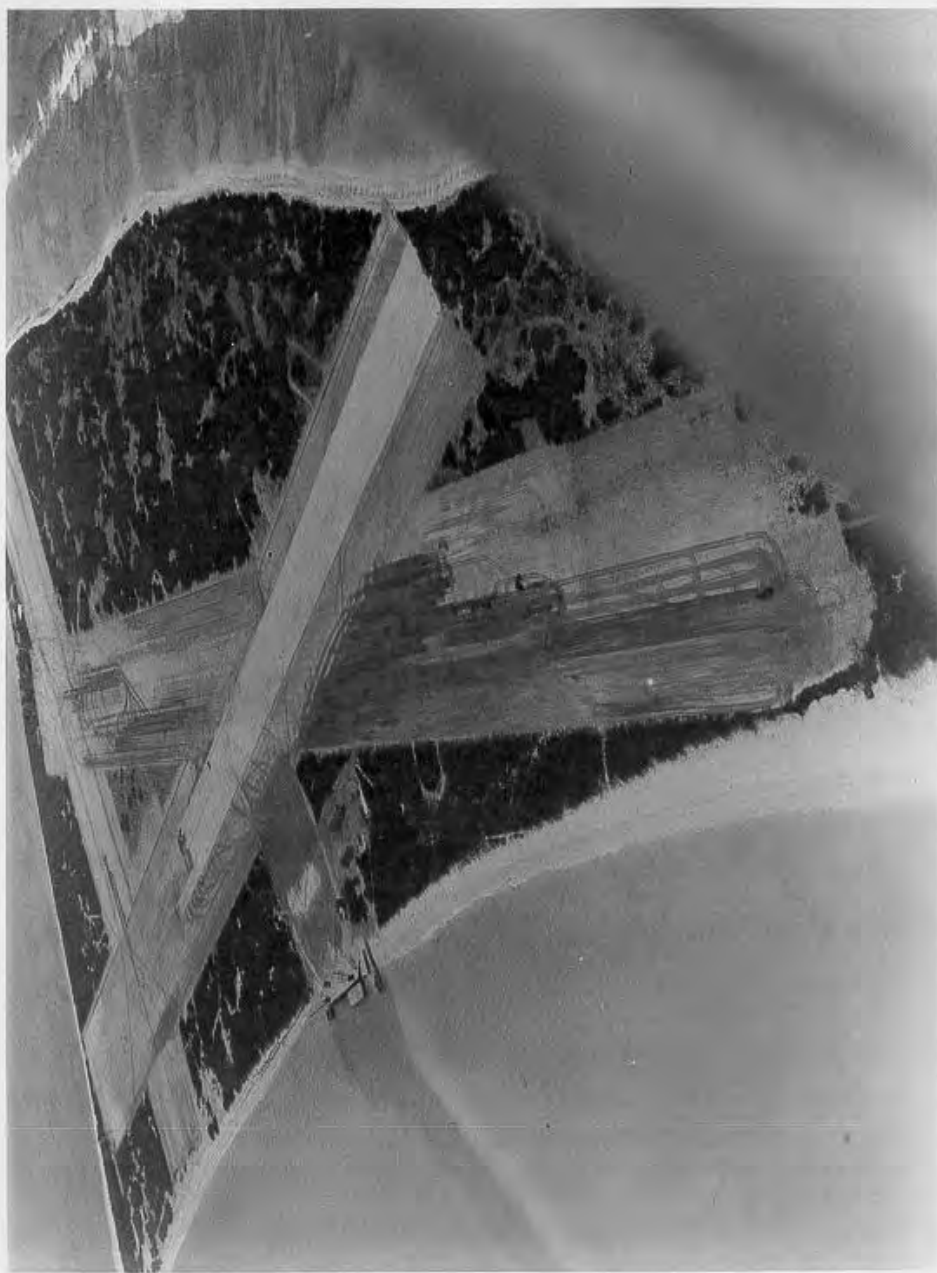
Figure 6. Aerial photo of Eastern Island, runways under construction, ca. 1941, declassified NND Project 868130 (Courtesy of the San Bruno National Archives, Neg. #114277).

Between 1939 and 1941, the Pacific Naval Air Base contractors built the various facilities on Midway. At first the focus was on expanding the harbor and developing a seaplane landing basin. Additionally, runways for land-based planes were constructed on Eastern Island (Figure 6). When construction projects were running full speed, there were approximately 1,500 men on Midway. The population boom required men to live in tents (Yoklavich 1993:22-24). Indeed, photographs of Sand Island taken at this time show several temporary barracks and rows of tents near the harbor (Figure 7).

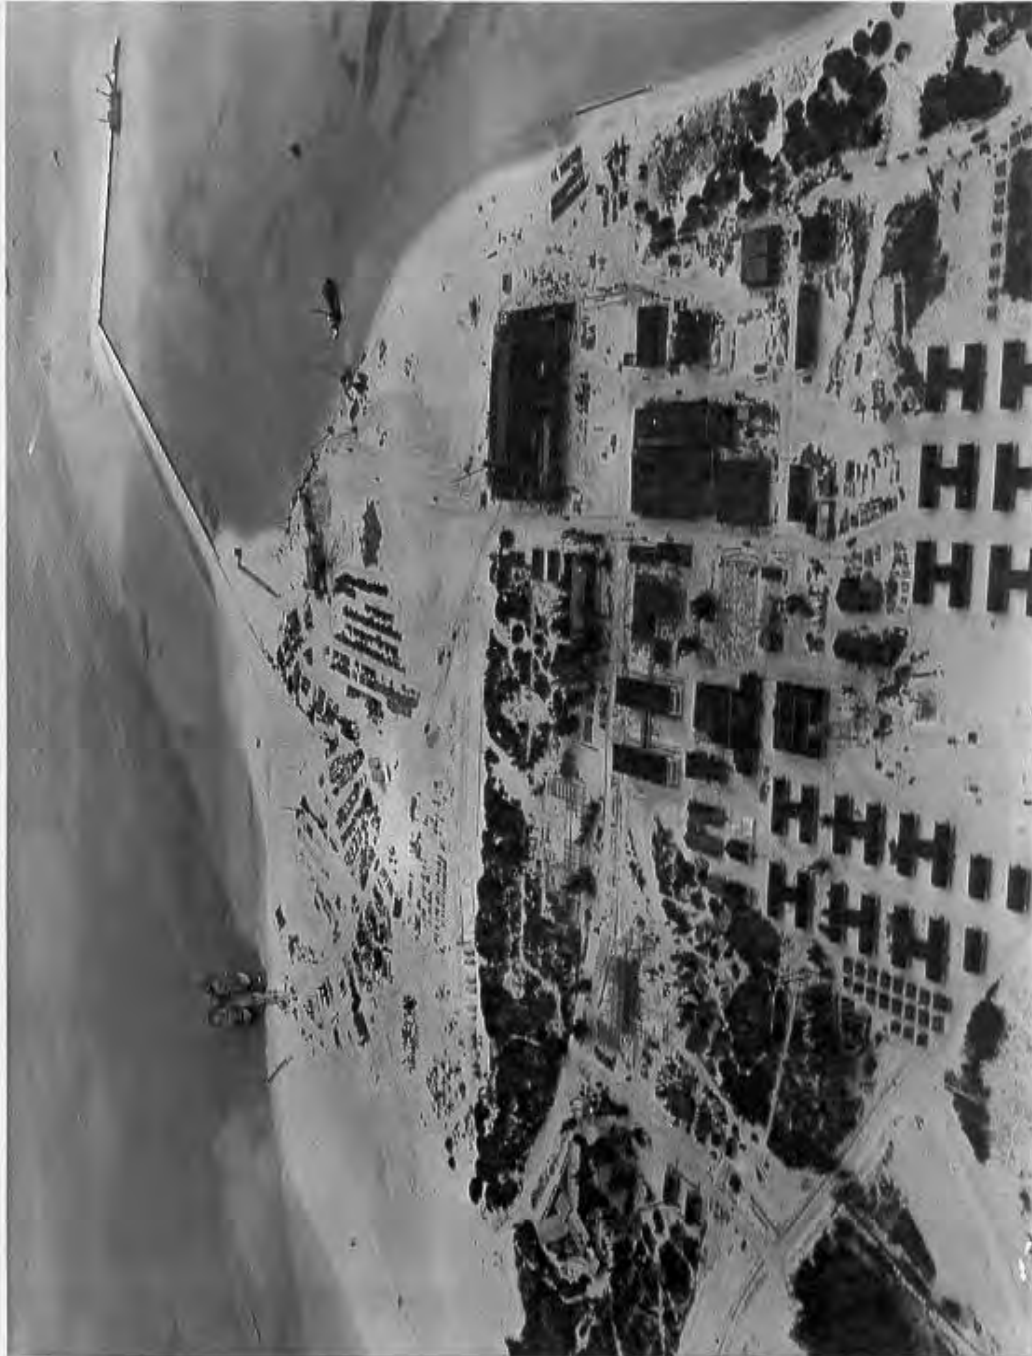
Figure 7. Aerial photo of Sand Island under construction in 1941, declassified, NND Project 868130 (Courtesy of the San Bruno National Archives).

In October 1940, the U.S. Army Engineers finally achieved a uniform 20-ft depth in the ship entrance channel to Sand Island, and the Naval supply ship *Sirius* was able to proceed inside the lagoon (Warshauer n.d.:194). The harbor area of Sand Island began to take on its current configuration as sheet piling was driven along the shoreline and dredged material was backfilled

to create a 2,800-ft bulkhead. A large seaplane parking mat was also constructed. Three concrete seaplane ramps provided egress from the lagoon. And, a large, steel-frame seaplane hangar was built (U.S. Navy, Bureau of Yards and Docks 1947 in Yoklavich 1993:24).

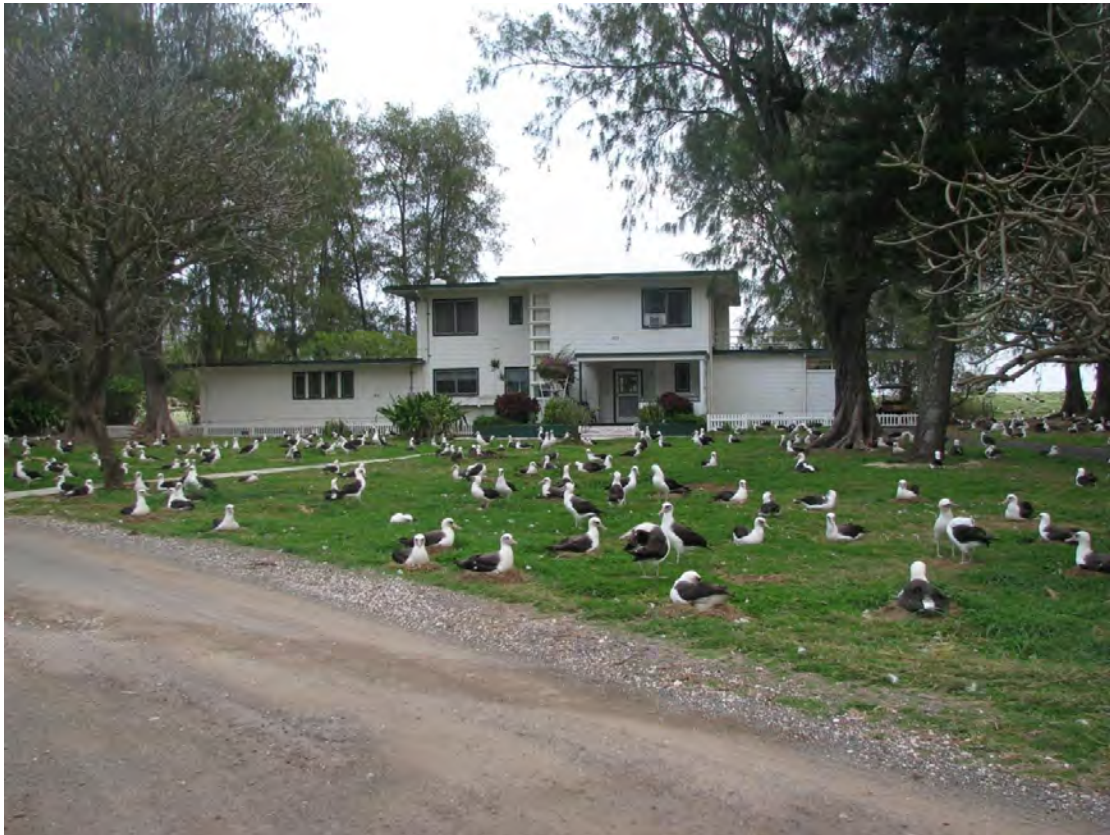
Figure 8. Officer-in-Charge House, designed by Albert Kahn (Speulda-Drews 2009-02-01:165).

The Navy contracted with architect Albert Kahn of Detroit, Michigan, “one of the country’s foremost industrial designers to prepare standardized plans for barracks, mess halls, and hangars for various bases” (Woodbury 1946:76 in Yoklavich 1993:24). Kahn’s firm was prolific. In 1937, it produced 19% of all architect-designed industrial buildings in the United States and from 1940 to 1942 was responsible for over \$200 million dollars in defense construction (Hyde 1996:21). Kahn was well known for his use of steel, reinforced concrete and natural light to create huge buildings with comfortable and functional interior spaces. The Officers’ housing reflects Kahn’s design versatility; the houses are functional and stylish with covered patios, fireplaces, large sliding doors and windows, servants’ quarters, and portal window porch details (Figure 8). Kahn also provided plans for barracks and the theater. The station plan replaced the individual units or “towns” with an overall design to meet the needs of the military and changed the civilian character of Sand Island.

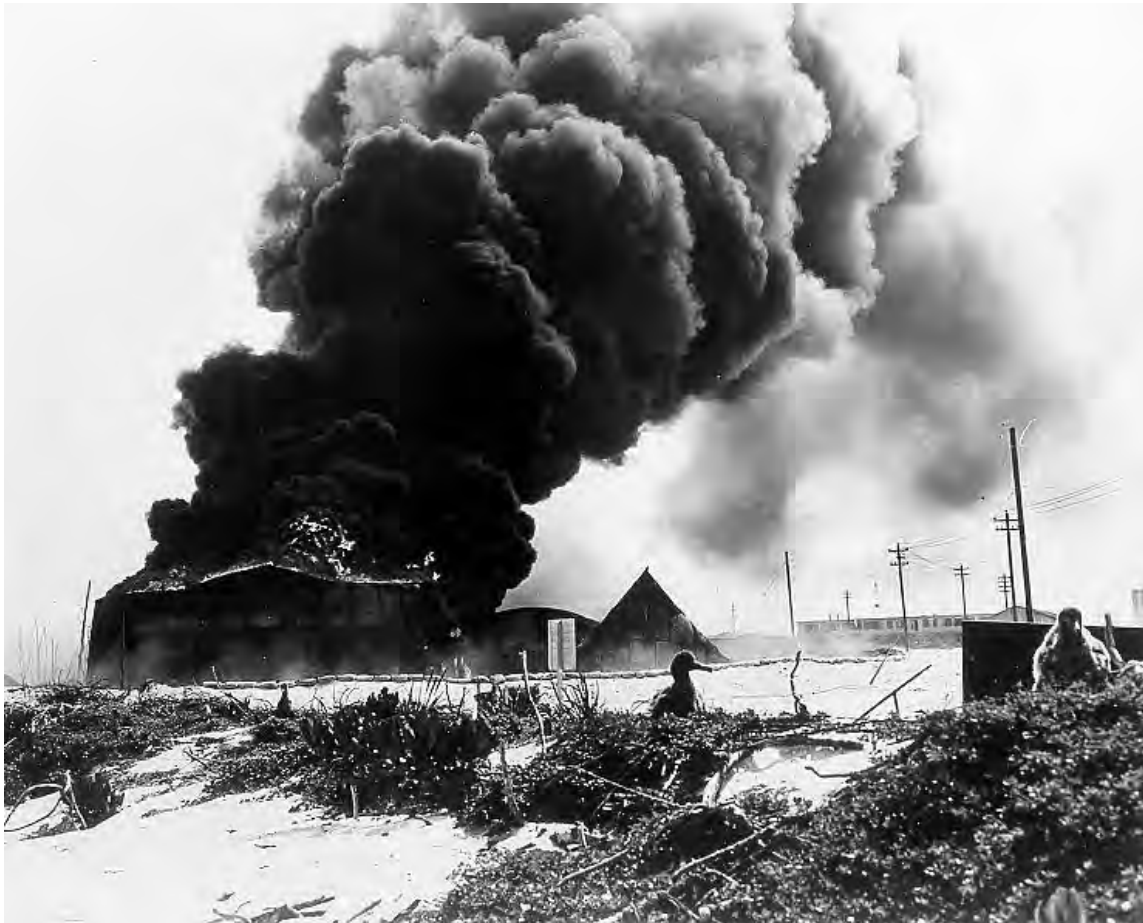
Figure 10. Damage caused by air strikes during Battle of Midway (San Bruno National Archives).

The seaplane hangar was hit and set ablaze. The fuel oil tanks 500 yards north of the seaplane hangar were also hit, sending a thick black column of smoke that could be seen for miles (Figure 10). Other facilities on Sand Island destroyed or damaged in the attack included the dispensary building, torpedo shop, administration building, laundry, transportation building, parachute loft, and Battery D, a three-inch battery located on the northwest shore of Sand Island. On Eastern Island, a large crater was blasted in the asphalt of runway number one and the mess hall, kitchen and food storehouse, power plant building, and salt water distillation equipment were hit.
